**DEPARTMENT OF TRANSPORTATION**

Contract #: 04-0120F4Cty: SF/ALA Rte: 80 PM: 13.2/13.9File #: 69.28**WELDING INSPECTION REPORT****Resident Engineer:**Siegenthaler, Peter**Address:** 333 Burma Road**City:** Oakland, CA 94607**Report No:** WIR-024011**Date Inspected:** 24-Apr-2011**Project Name:** SAS Superstructure**OSM Arrival Time:** 1500**Prime Contractor:** American Bridge/Fluor Enterprises, a JV**OSM Departure Time:** 300**Contractor:** Zhenhua Port Machinery Company, Ltd (ZPMC), Changxing Island **Location:** Shanghai, China**CWI Name:** Mr. Li Yan Hua**CWI Present:** Yes No**Inspected CWI report:** Yes No N/A**Rod Oven in Use:** Yes No N/A**Electrode to specification:** Yes No N/A**Weld Procedures Followed:** Yes No N/A**Qualified Welders:** Yes No N/A**Verified Joint Fit-up:** Yes No N/A**Approved Drawings:** Yes No N/A**Approved WPS:** Yes No N/A**Delayed / Cancelled:** Yes No N/A**Bridge No:** 34-0006**Component:** OBG**Summary of Items Observed:**

## WELDING INSPECTION REPORT

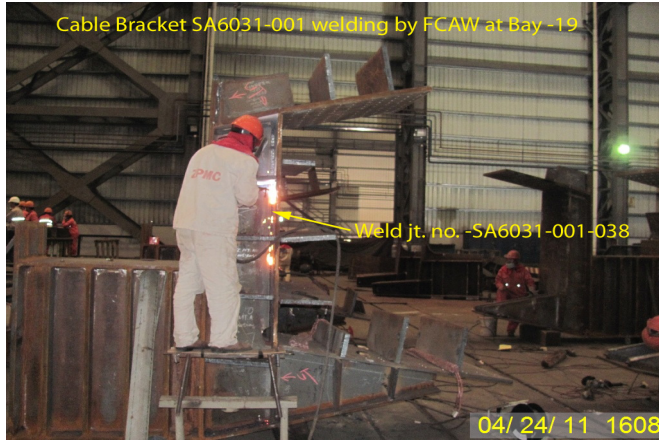
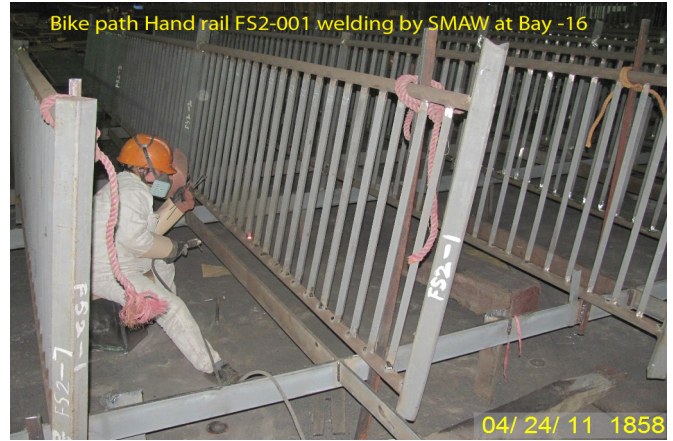
For further information see below pictures:-

Unless otherwise noted, all work observed on this date appeared to be in general compliance with the applicable contract documents.
